How to Get Bigger and Better TELEVISION IMAGES

Robert Eichberg

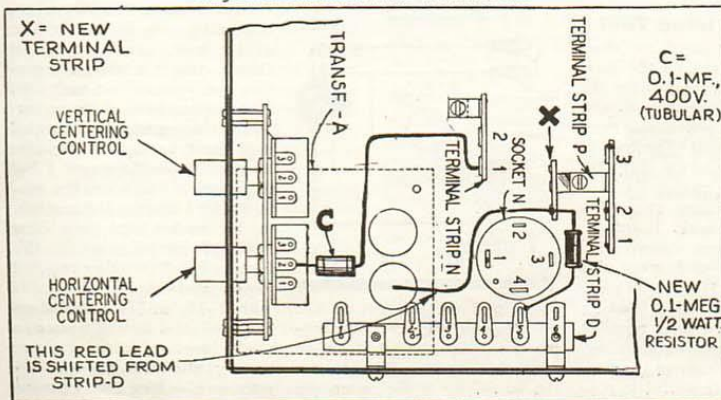
Diagram of alterations made in Andrea kit.

Due to excessively high voltage, the image could not be expanded to fill the en-

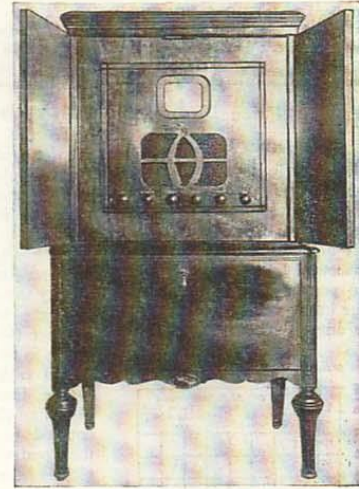
Andrea Kit installed in Console.

● AS no cabinet is provided for the kit model Andrea television set, the writer got in touch with a distributor of merchandise whose ad in *RADIO & TELEVISION* showed an old Kolster cabinet of approximately correct dimensions.

While this cabinet is not quite as deep as the assembled kit, a hole may be cut in the back to accommodate the C-R tube and bracket. A removable panel takes care of the chassis depth.

In the cabinet, as it is supplied, there is an old Kolster R.F. unit and a loud speaker baffle. These were removed. A piece of walnut veneer plywood was used to fill the panel space in the cabinet, which was considerably larger than the panel supplied in the Andrea kit. Centering this panel on the plywood necessitated raising the chassis some three inches from the bottom of the cabinet compartment. This was done by means of a small platform built out of boards—the very boards with which the cabinet was secured in its packing case.

The legs on the cabinet are cross-braced, but as it was a little too high for comfortable viewing when the observer was seated, these legs were sawed off just above the brace, lowering the cabinet about four inches.
